P R O J E C T S

Silicones end patchwork

Eggshells and elevators leak no more, thanks to silicones

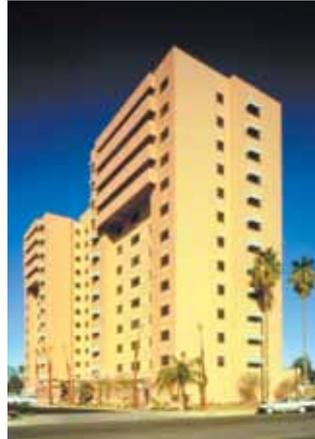
The Towers, Mesa, Arizona

Years of waterproofing repairs with urethane sealants had not cured persistent leaks in a 22-story apartment building in Mesa, Arizona. The repairs gave the building a patchwork look, and still let in rain during storms. As water infiltration continued through the joints, some of the structure’s Exterior Insulation and Finish System (EIFS) panels began to deteriorate. The building was only about 12 years old.

“The nature of the problems led us to recommend *Dow Corning® 123 Silicone Seal* and *Dow Corning® AllGuard Silicone Elastomeric Coating*,” said Matt Shane of SpecTech Systems Corporation. “By using *Dow Corning 123 Silicone Seal* in the 2-inch width, we proceeded without having to remove the old sealant.” With no need for labor-intensive removal of failed sealant, renovation went faster and cost less.

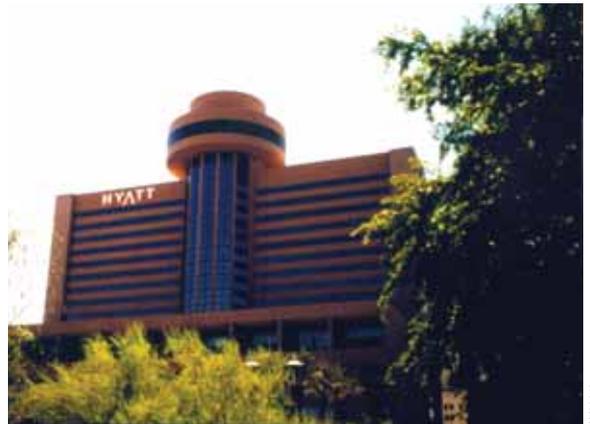
Hyatt Regency, Phoenix, Arizona

In 1997, it was obvious that 20 years of sun, heat and torrential rain had taken their toll on the glass curtainwall, stucco, split block, and EIFS exterior of the *Hyatt Regency* in Phoenix, Arizona.

To repair the problems, Jerome O’Connor, then consulting engineer for Law Engineering and Environmental Services, Inc., of Itasca, Illinois, recommended a complete building envelope solution. O’Connor recommended *Dow Corning® 795 Silicone Building Sealant* for wet sealing window glass to frames; *Dow Corning® 790 Silicone Building Sealant* for joints between stucco panels and to pre-seal larger cracks in the stucco; *Dow Corning® 123 Silicone Seal* for the horizontal

joints between the strip windows and the stucco panels as well as the gaps at the elevator shafts; and *Dow Corning*[®] AllGuard Silicone Elastomeric Coating to waterproof the building's various substrates.

SpecTech Systems Corporation of Bradenton, Florida, performed the job in about four months. Control joints were stripped, filled with new backer rod, and sealed with *Dow Corning* 795 Sealant. Primer and two coats of *Dow Corning* AllGuard were applied.

The renovation turned out beautifully, with uniform, crisp color, says Bill Hickman, Hyatt building engineer. The matte finish characteristic of the newly reformulated *Dow Corning* AllGuard Elastomeric Coating laid to rest all concerns about a shiny appearance. "It's the ultimate repair," he said. "It solved all the problems, and we haven't had a leak since."
